Project Zero

Comparative Testing of Antifouling Coatings

Report number : RPT24011
Date : December 11, 2024
Version : VP

Comparative testing of antifouling coatings

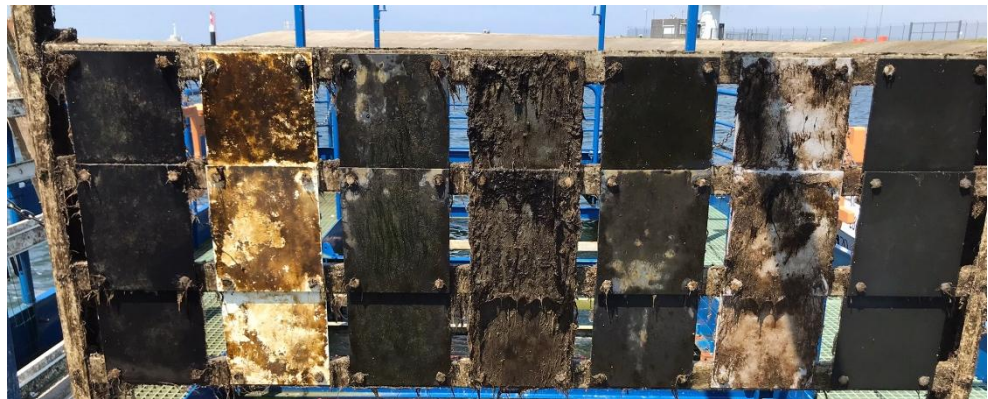
During the first visual inspection, 5 weeks after immersion (T1, Table 1), biofouling growth and coverage varied between and within coatings (Figure 4). All coatings displayed biofilm (aka slime) growth. Macrofouling taxa attached to the coatings included algae, tunicates, hydroids, and bryozoa (Figure 5). Along with a high coverage of hydroids, barnacles were present on the uncoated PVC panels.

Figure 4: Biofouling growth on coated panels after 5 weeks of exposure (T1) – from left to right: Hempablue, Nautix, Jotun, PVC (control), Trilux, Intersleek and Hempaguard. Three replicas of each coating are stacked vertically and denoted as A, B, and C from top to bottom.

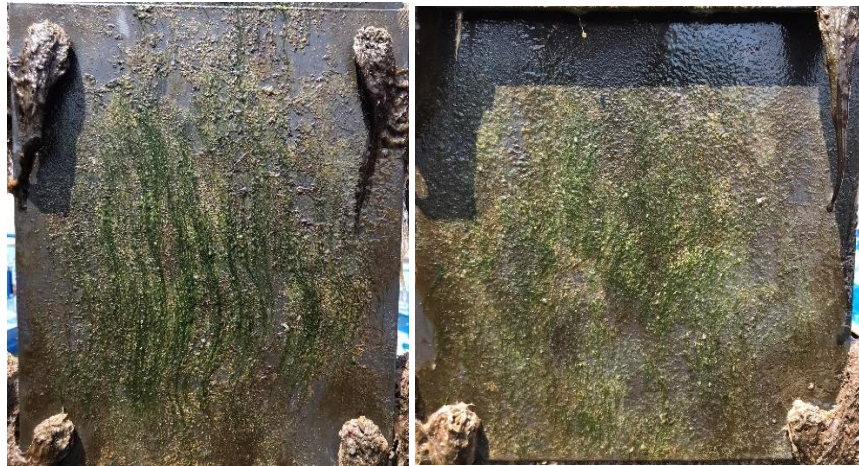
Hempablue, Nautix, and Hempaguard only had biofilm growth, with Hempaguard having the lowest coverage of biofilm. Jotun showed attachment of filamentous green algae (Figure 6). Trilux had growth of young tunicates on replica A and B. All three replicas also had macroalgae growth, however due to the size of the macroalgae it is considered as a part of the biofilm (in accordance with ECHA 2018). Intersleek was colonised by hydroids and some bryozoa. Biofouling coverage decreased with depth for certain coatings (Hempablue, Nautix, Trilux). All paints were able to prevent barnacle attachment, although their growth on the uncoated PVC panels did not indicate a high settlement pressure when compared to other taxa on T1.

Figure 6: Algae growth on Jotun A (left) and B (right) during the first inspection date (T1). Note that macroalgae coverage is calculated using only the initial attachment points.

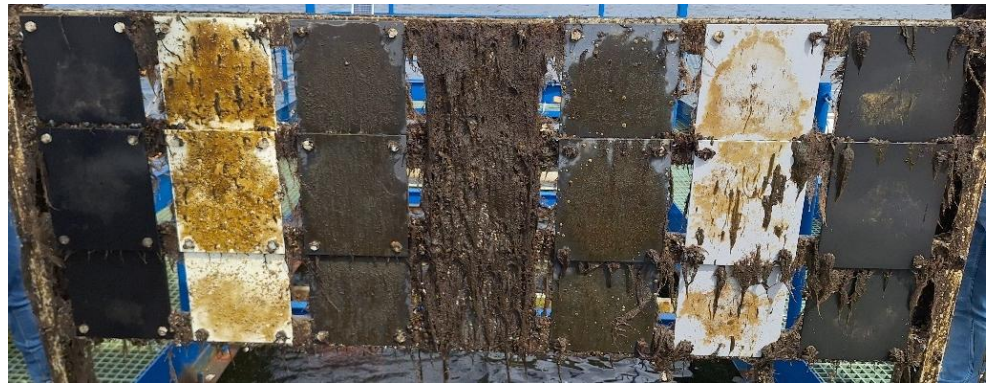
After 10 weeks of exposure (T2) (Figure 8,9), barnacles were able to settle on Nautix and Trilux (Figure 10, 11), however they were more prevalent on Nautix. Hempablue and Hempaguard were the only coatings without any macrofouling. In addition, Hempablue had a slightly lower biofilm coverage when compared to T1. Mussels started attaching to the PVC panels, indicating a settlement pressure from these taxa. However, they were not able to attach to any of the coated panels. Algal coverage only includes the attachment area, the increase in length is not reflected in the biofouling coverage. Intersleek coverage changed from mainly hydroids to mainly algae, and had a decrease in total biofouling coverage compared to T1.

Figure 8: Biofouling growth on coated panels after 10 weeks of exposure (T2) – from left to right: Hempablue, Nautix, Jotun, PVC (control), Trilux, Intersleek and Hempaguard. Three replicas of each coating are stacked vertically and denoted as A, B, and C from top to bottom.

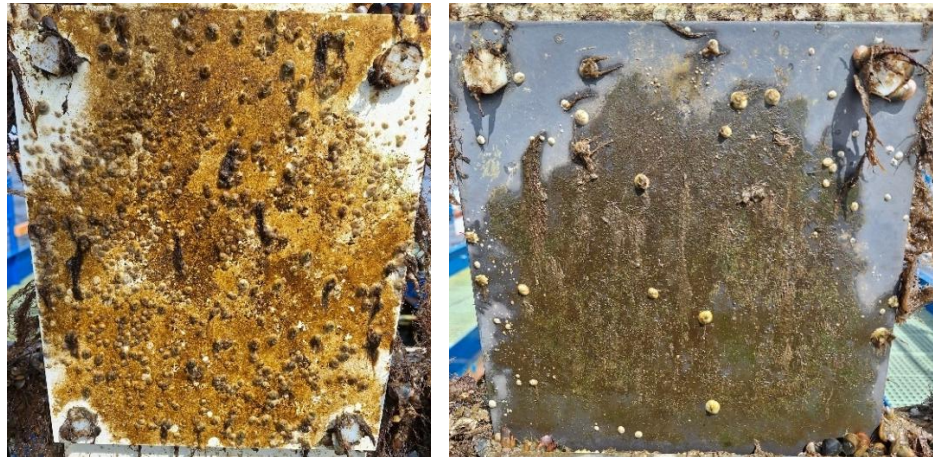
Figure 11: Left: Nautix B T2 with barnacle growth. Algae was attached to the barnacles but not to the panel. Right: Trilux A T2 with barnacle growth and hydroids.

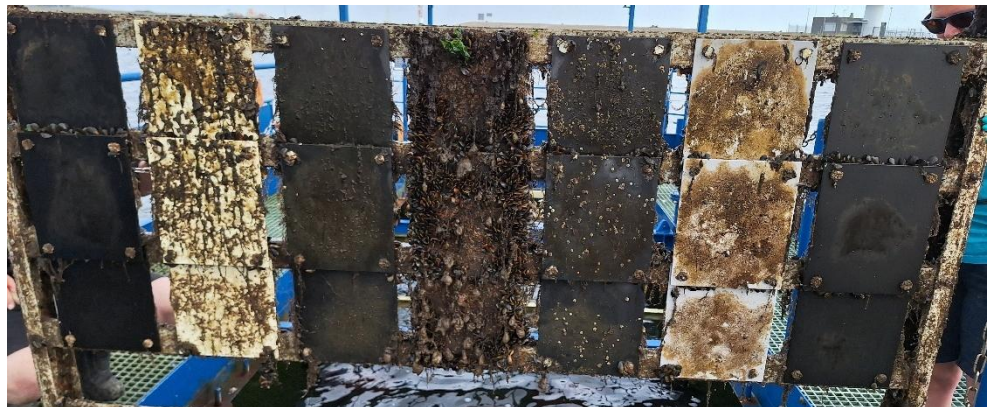
After 15 weeks of exposure (T3), the Hempablue panels had a moderate biofilm level, with the deepest replica (Hempablue C) having the least amount of biofilm (Figure 12, 13). Nautix still showed high levels of barnacle settlement, with slight attachment of tunicates, hydroids, and algae. Jotun displayed comparable biofouling coverage to T2, with some attachment of barnacles and tunicates. Tunicates were able to grow on Trilux as well. Taxa coverage and diversity was high for Intersleek, where bryozoa, barnacles, and tubeworms were able to attach, which were rarely seen on this coating during T1 and T2. Hempaguard had the lowest biofilm growth and no macrofouling taxa were attached on them. The PVC panels displayed growth of tunicates, barnacles, and mussels.

Figure 12: Biofouling growth on coated panels after 15 weeks of exposure (T3) – from left to right: Hempablue, Nautix, Jotun, PVC (control), Trilux, Intersleek and Hempaguard. Three replicas of each coating are stacked vertically and denoted as A, B, and C from top to bottom.

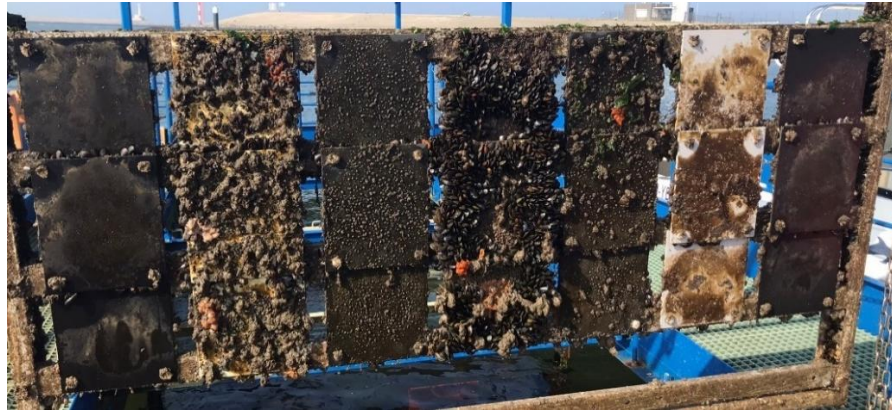
After 20 weeks of exposure (T4), Hempablue displayed slightly higher biofilm growth than previous dates but still showed resilience towards the attachment of macrofouling species (Figure 15, 16). All three Nautix panels were highly fouled with tunicates (Figure 17, 18). The barnacles seen in previous time points were likely covered by the tunicates, which made characterization of the barnacles difficult. While Jotun was covered with algae during T1 to T3, algae were absent from Jotun panels during T4. Jotun and Trilux, were covered with amphipods and their mud tubes. Since these motile species are rarely seen on ship hulls and are likely an artifact of static exposure experiments, they are not taken into account for the biofouling coverage (in accordance to ASTM D 6990 – 20 and ECHA, 2018). Barnacles were seen on Trilux beneath the mud tubes, and in small amounts on the PVC panels. Tunicates were seen on all Trilux and Intersleek replicas. Macrofouling coverage on Intersleek B was high, with growth of tunicates, bryozoa and tubeworms (Figure 18). Tubeworms were only seen on the Intersleek panels throughout the exposure period. Hempaguard displayed an increase in biofilm coverage compared to previous dates, especially in replica B. However, they still displayed the lowest growth on average and prevented macrofouling taxa from attaching. PVC panels displayed high levels of mussel growth, along with tunicates, hydroids and barnacles, although the barnacles were most likely dead. Since the dead barnacles when attached on a ship's hull can still have an effect on drag and are difficult to remove, they are still considered in the fouling evaluation.

Figure 15: Biofouling growth on coated panels after 20 weeks of exposure (T4) – from left to right: Hempablue, Nautix, Jotun, PVC (control), Trilux, Intersleek and Hempaguard. Three replicas of each coating are stacked vertically and denoted as A, B, and C from top to bottom.

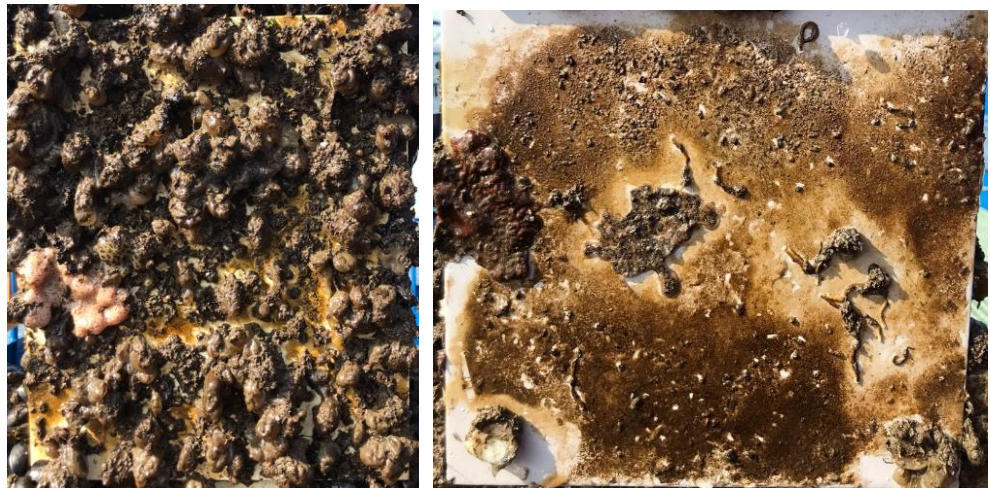
Nautix had a macrofouling coverage up to 85% (Figure 17). Intersleek B and C had slight increases in macrofouling growth compared to T3. Barnacle coverage on the Trilux coatings decreased slightly compared to T4, but this may have been due to the difficulty of assessing barnacle growth which was covered by other species and amphipod mud tubes.

Figure 18: Closeups of macrofouling growth on panels during the T4 inspection. Solitary tunicate growth on Nautix B (left), Tubeworms and colonial tunicate growth on Intersleek C (right).

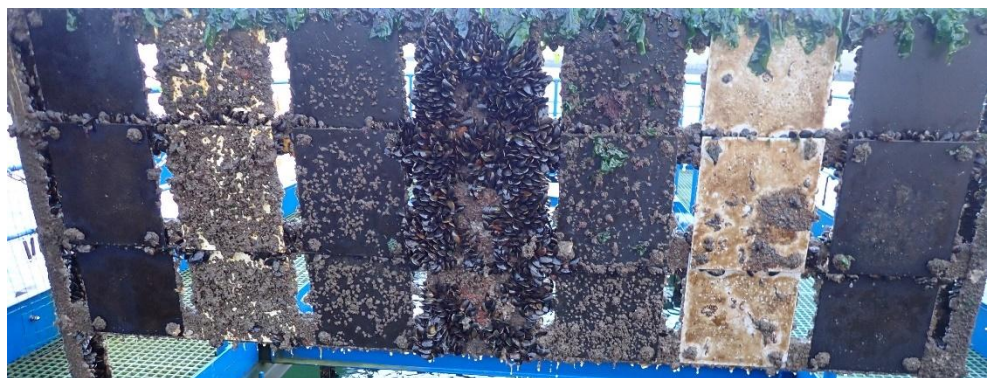
After 25 weeks of exposure (T5), Hempablue maintained moderate levels of biofilm without any growth of macrofouling species (Figure 19, 20). Tunicate pressure had decreased on the Nautix panels and was instead replaced by amphipod mud tubes. The mud tubes were often present on or around barnacles, using their sturdy makeup as a foundation. Mud tubes were also present on Jotun and Trilux panels. While the mud tubes were surrounding barnacles on the Trilux panels, the Jotun panels were free of barnacles, resulting in a less sturdy attachment of the mud tubes directly on the coating. Aside from the mud tubes, the Jotun panels were only covered by biofilm with levels lower than previous dates for replicas B and C. The Trilux panels had barnacles attached to the coating, with secondary structures (mud tubes, green and red seaweed) growing over them. Intersleek panel B had high growth of bryozoa, along with several tubeworms. The bryozoa were absent on the Intersleek A replica. Hempaguard still displayed low levels of biofilm growth, however juvenile barnacles were found attached to the coating. While still in low numbers and size, this does indicate a potential for barnacles to attach to this coating after extended periods of idleness.

Figure 19: Biofouling growth on coated panels after 25 weeks of exposure (T5) – from left to right: Hempablue, Nautix, Jotun, PVC (control), Trilux, Intersleek and Hempaguard. Three replicas of each coating are stacked vertically and denoted as A, B, and C from top to bottom.

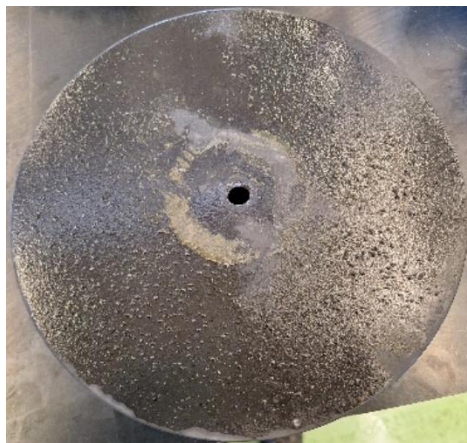
Figure 28: Algae attached to Jotun (R2) after the first FDM run after 12 weeks of raft exposure

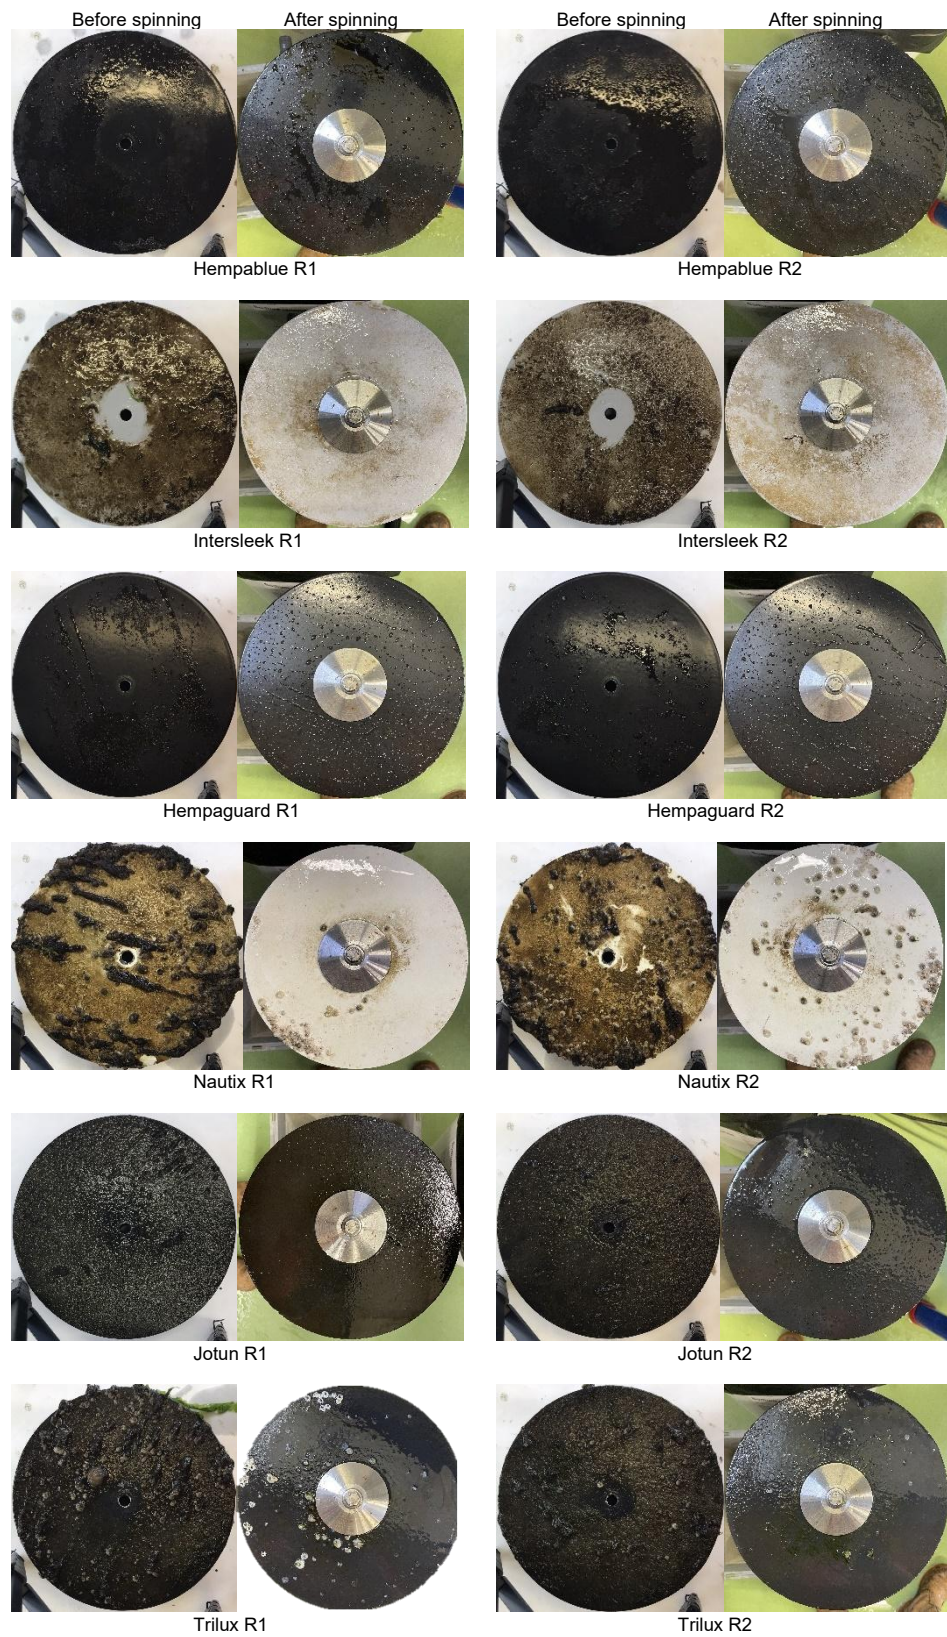
Plate 1: Discs that were exposed on the raft for 12 weeks, before and after spinning on the FDM for the first run.
