Project Zero

Comparative Testing of Antifouling Coatings

Report number : RPT24011
Date : December 11, 2024
Version : VP

Comparative testing of antifouling coatings

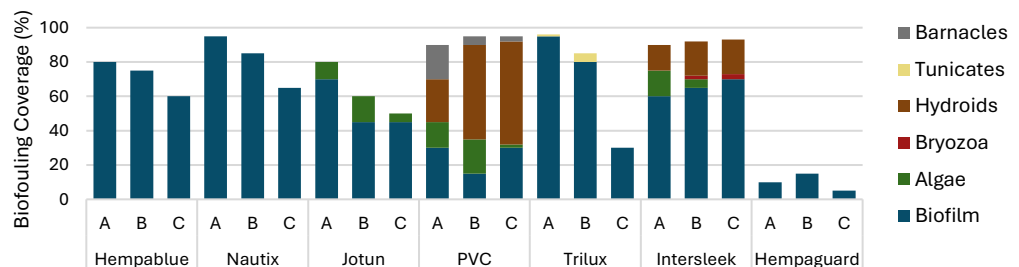
During the first visual inspection, 5 weeks after immersion (T1, Table 1), biofouling growth and coverage varied between and within coatings (Figure 4). All coatings displayed biofilm (aka slime) growth. Macrofouling taxa attached to the coatings included algae, tunicates, hydroids, and bryozoa (Figure 5). Along with a high coverage of hydroids, barnacles were present on the uncoated PVC panels.

Figure 5: Biofouling coverage (%) during T1 per replica of each coated panel and the uncoated PVC panels. The edges of the panels are not included in the assessment of biofouling coverage. A, B, C indicate different replicas.

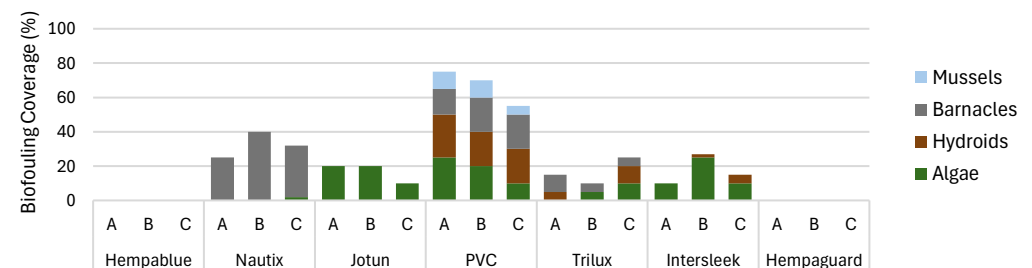
When looking at the coverage of macrofouling taxa (Figure 10), Nautix had the highest coverage, consisting predominantly of barnacles. Jotun, Trilux and Intersleek had a relatively low fouling coverage consisting of mainly algae for Jotun and Intersleek, and barnacles for Trilux.

Figure 10: Macrofouling coverage (%) during T2 per replica of each coated panel and the uncoated PVC panels. Does not include biofilm. The edges of the panels are not included in the assessment of biofouling coverage. A, B, C indicate different replicas.

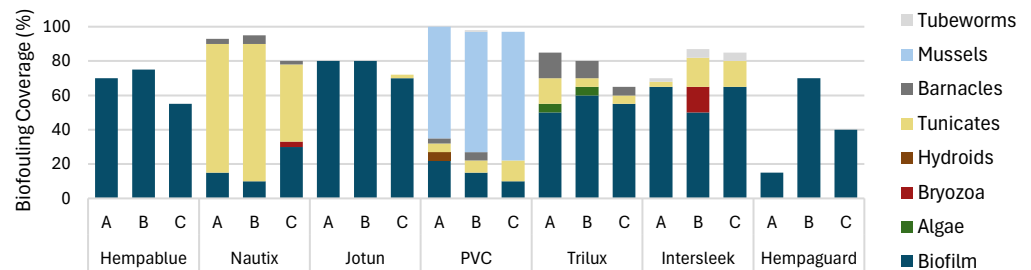
After 20 weeks of exposure (T4), Hempablue displayed slightly higher biofilm growth than previous dates but still showed resilience towards the attachment of macrofouling species (Figure 15, 16). All three Nautix panels were highly fouled with tunicates (Figure 17, 18). The barnacles seen in previous time points were likely covered by the tunicates, which made characterization of the barnacles difficult. While Jotun was covered with algae during T1 to T3, algae were absent from Jotun panels during T4. Jotun and Trilux, were covered with amphipods and their mud tubes. Since these motile species are rarely seen on ship hulls and are likely an artifact of static exposure experiments, they are not taken into account for the biofouling coverage (in accordance to ASTM D 6990 – 20 and ECHA, 2018). Barnacles were seen on Trilux beneath the mud tubes, and in small amounts on the PVC panels. Tunicates were seen on all Trilux and Intersleek replicas. Macrofouling coverage on Intersleek B was high, with growth of tunicates, bryozoa and tubeworms (Figure 18). Tubeworms were only seen on the Intersleek panels throughout the exposure period. Hempaguard displayed an increase in biofilm coverage compared to previous dates, especially in replica B. However, they still displayed the lowest growth on average and prevented macrofouling taxa from attaching. PVC panels displayed high levels of mussel growth, along with tunicates, hydroids and barnacles, although the barnacles were most likely dead. Since the dead barnacles when attached on a ship's hull can still have an effect on drag and are difficult to remove, they are still considered in the fouling evaluation.

Figure 16: Biofouling coverage (%) during T4 per replica of each coated panel and the uncoated PVC panels. The edges of the panels are not included in the assessment of biofouling coverage. A, B, C stands for different replicas.

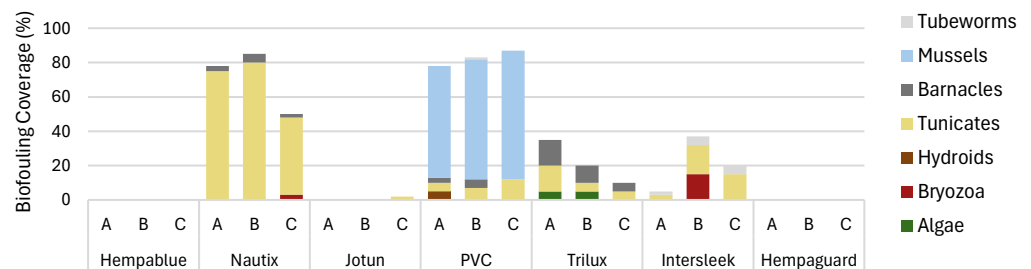
Nautix had a macrofouling coverage up to 85% (Figure 17). Intersleek B and C had slight increases in macrofouling growth compared to T3. Barnacle coverage on the Trilux coatings decreased slightly compared to T4, but this may have been due to the difficulty of assessing barnacle growth which was covered by other species and amphipod mud tubes.

Figure 17: Macrofouling coverage (%) during T4 per replica of each coated panel and the uncoated PVC panels. Does not include biofilm. The edges of the panels are not included in the assessment of biofouling coverage. A, B, C stands for different replicas.

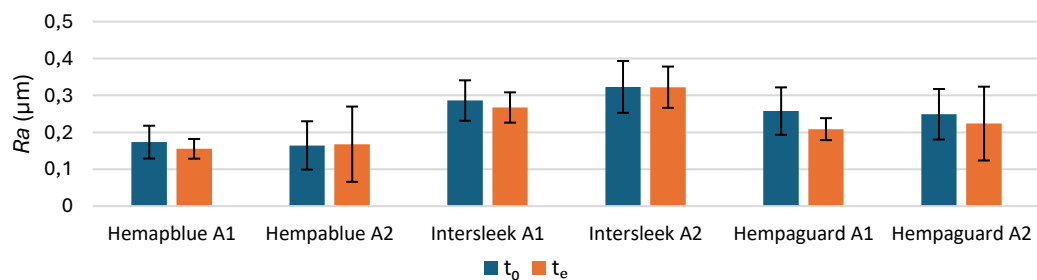
Average surface roughness (R_a) of the different coatings was measured before (t_0) and after (t_e) aging coated discs for 10 weeks (Figure 22, Figure 23). R_a values were consistently lower for FRC (0,15 μm - 0,32 μm) compared to non-FRCs (0,85 μm - 1,65 μm).

R_a did not change considerably after aging for all the FRCs. Hempablue had the lowest average R_a (0,17 – 0,15 average R_a before and after aging respectively across both replicas) while Intersleek A2 had the highest average out of the FRCs (0,32 μm before and after).

Figure 22: Roughness values (R_a) of FRCs before (t_0) and after (T_e) aging. Error bars indicate the standard deviation within each replica (N=36). A1 = Aging Replica 1, A2 = Aging Replica 2

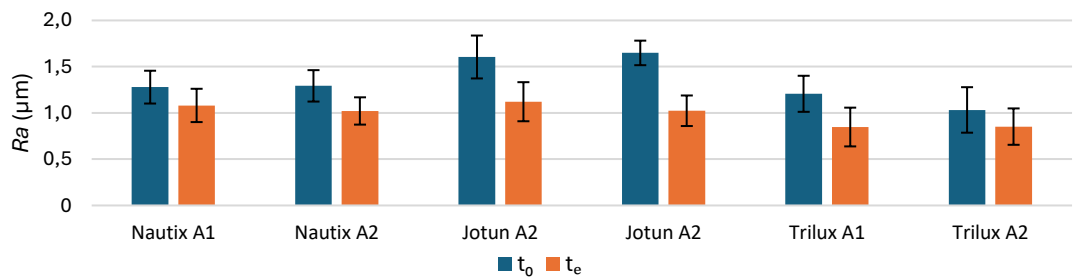
For the non-FRCs (Figure 23), average R_a values were consistently lower after aging for each coating (average of 1,34 μm and 0,99 μm at t_0 and t_e respectively), however the averages were still within the standard deviation of each other except for Jotun A2, which had the largest effect of aging on surface roughness. Jotun had the highest surface roughness. Trilux and Nautix had comparable surface roughness values before aging, however Trilux discs had a lower roughness following the aging treatment compared to Nautix.

Figure 23: Roughness values (R_a) of non-FRCs before (t_0) and after (T_e) aging. Error bars indicate the standard deviation within each replica ($N=36$). A1 = Aging Replica 1, A2 = Aging Replica 2

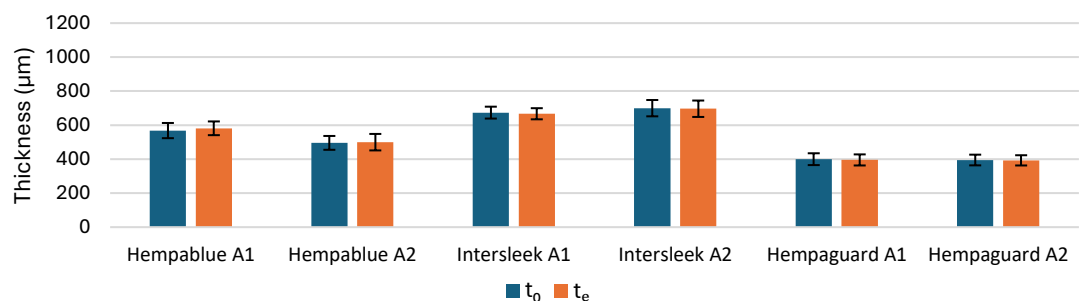
Coating thickness was measured before and after aging. For the FRCs, Hempaguard had the lowest thickness (Figure 24). Hempablue and Intersleek had comparable levels of thickness. After 10 weeks of aging, no clear effect was observed on the thickness.

Figure 24: Thickness values (μm) of FRCs before (t_0) and after (T_e) aging. Error bars indicate the standard deviation within each replica ($N=36$). A1 = Aging Replica 1, A2 = Aging Replica 2

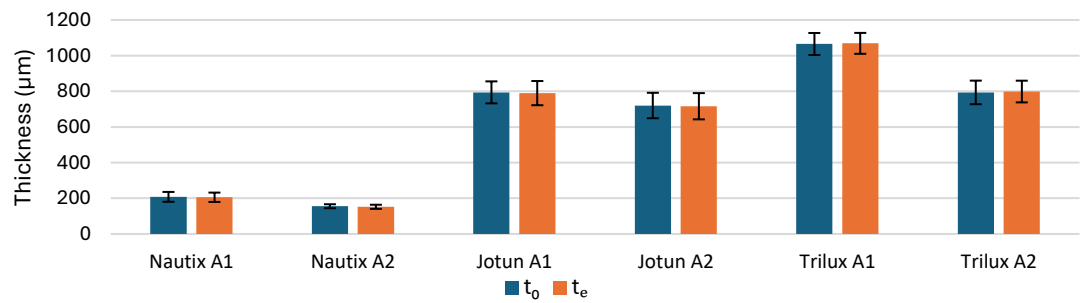
For the non-FRCs, Nautix had the lowest thickness while replica Trilux A1 had the highest thickness (Figure 25). Trilux had the largest difference between the two replicas. Dynamic aging for 10 weeks did not measurably affect the coating thickness.

Figure 25: Thickness values (μm) of non-FRCs before (t_0) and after (t_e) aging. Error bars indicate the standard deviation within each replica (N=36). A1 = Aging Replica 1, A2 = Aging Replica 2

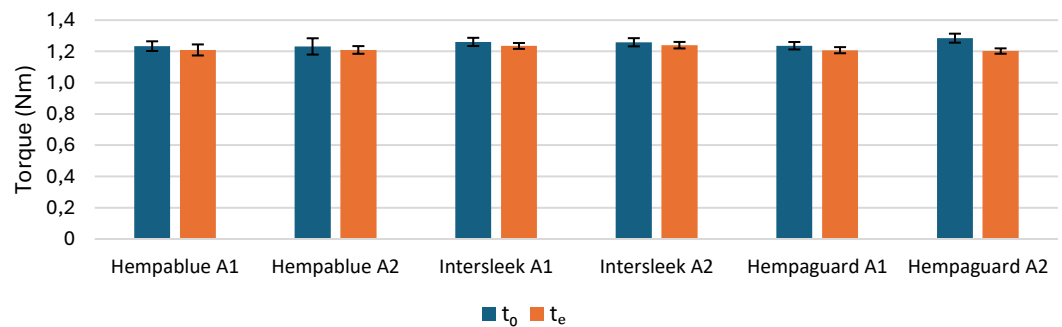
The twelve coated discs were spun on the friction disc machine to measure torque over a range of RPM speeds (500 RPM – 1500 RPM). Measurements were done before and after aging for 10 weeks. FDM values (averaged over all RPM values) between t_0 and t_e (Figure 26) did not appear different from each other. Hempaguard A2 displayed a slight decrease in torque values after aging, but this is not the case for Hempaguard A1.

Figure 26: FDM torque values of FRCs before (t_0) and after (t_e) aging. Values from the different RPM values were averaged. Error bars indicate the average standard deviation across all RPM values. A = Aging, 1 and 2 denote replicas.

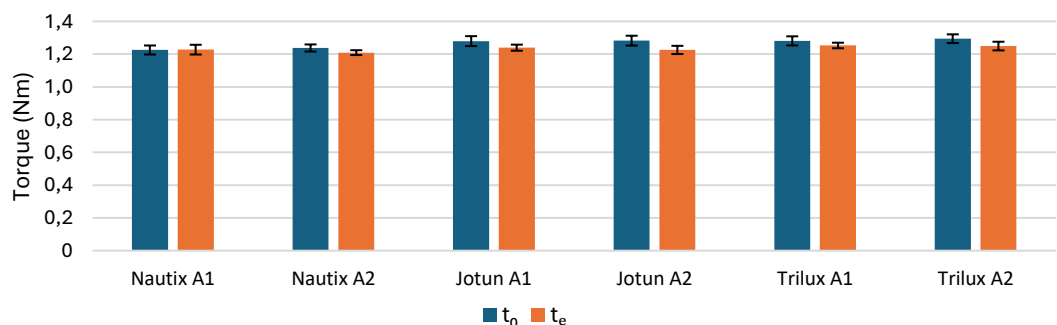
For the non-FRCs, torque values were relatively similar to the FRCs (Figure 27). A slight decrease in torque values after aging was seen for Jotun and Trilux.

Figure 27: FDM torque values of non-FRC before (t_0) and after (t_e) aging. Values from the different RPM values were averaged. Error bars indicate the average standard deviation across all RPM values. A1 = Aging Replica 1, 2 = Aging Replica 2

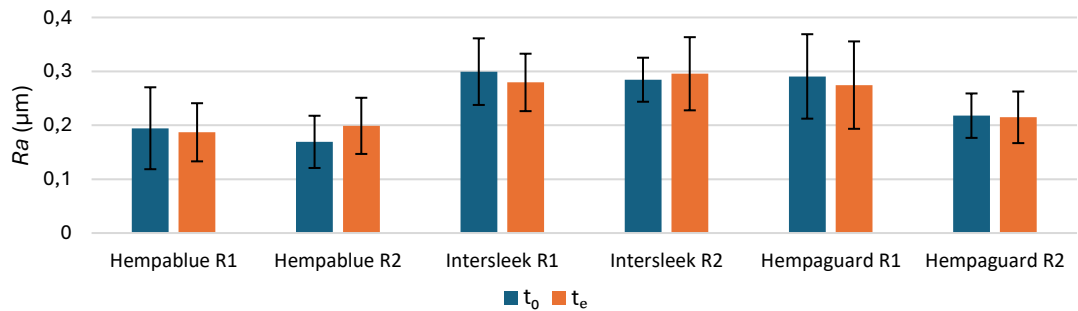
Average surface roughness (R_a) of the coatings was measured before and after exposure on the raft. FRCs had lowered R_a values (average of 0,243 μm and 0,242 μm for t_0 and t_e respectively) (Figure 29) compared to the non-FRCs (average of 1,21 μm and 1,15 μm) (Figure 30). For FRCs, R_a values did not change considerable after raft exposure.

Figure 29: Roughness values (R_a) of FRCs before (t_0) and after (T_e) raft exposure. Error bars indicate the standard deviation within each replica ($N=36$). R1 = Raft Replica 1, R2 = Raft Replica 2

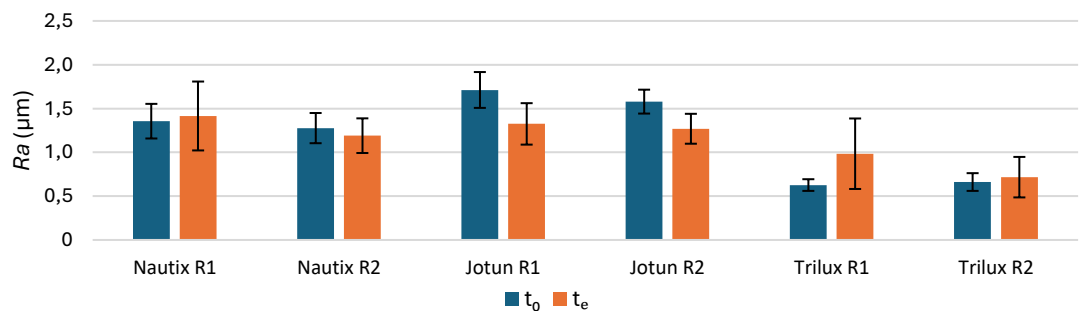
For the non-FRCs (Figure 30), average R_a values varied slightly before and after raft exposure, although always within the standard deviation. Jotun displayed slightly lowered R_a values after exposure for both replicas while Trilux R1 had a slightly higher surface roughness after exposure.

Figure 30: Roughness values (R_a) of non-FRCs before (t_0) and after (T_e) raft exposure. Error bars indicate the standard deviation within each replica ($N=36$). R1 = Raft Replica 1, R2 = Raft Replica 2

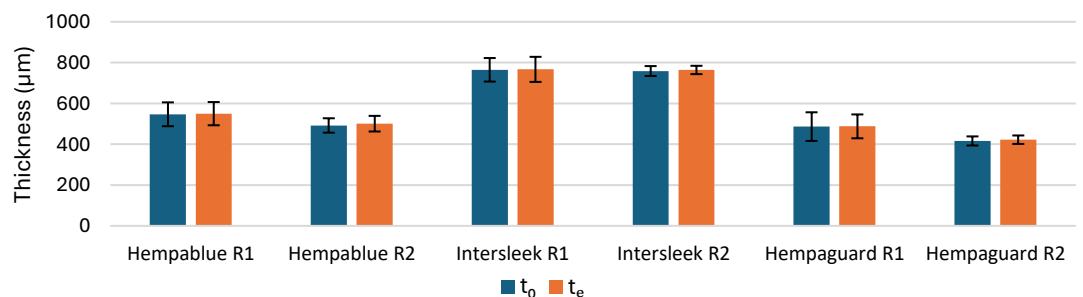
Coating thickness of the discs was measured before and after exposure of the coatings on the raft (Figure 31 and Figure 32). Exposure on the raft for 12 weeks did not alter coating thickness to a measurable degree in all FRCs and non-FRCs. FRCs had slightly lower thickness than non-FRCs, except for both replicas of Nautix, which had the thinnest coating application.

Figure 31: Thickness values (μm) of FRCs before (t_0) and after (T_e) raft exposure. Error bars indicate the standard deviation within each replica ($N=36$). R1 = Raft Replica 1, R2 = Raft Replica 2
